## Errata: CS4340A Rev. B

(Reference CS4340A Data Sheet revision DS590PP1 dated JUN' 02)

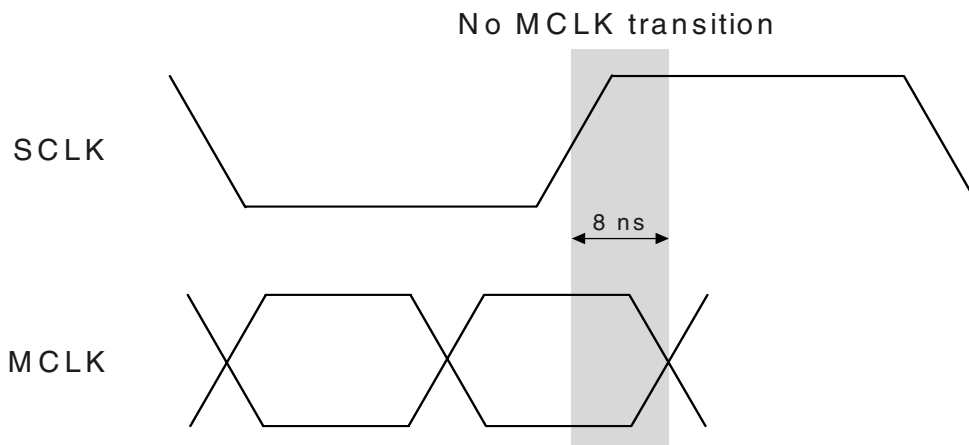
Figure 1. SCLK to MCLK Timing

- The device does not function properly during certain phase relationships of MCLK and SCLK in Quad-Speed Mode. MCLK must not transition 0 ns to 8 ns after the rising edge of SCLK. Should a transition occur within this window, the resulting symptom will be severe distortion of the audio signal.

Note: The timing relationship is limited to a window of less than 1 ns on any individual part. However, the location of this 1 ns window across multiple devices is within the 8 ns window shown in the figure above.
